PERFORMANCE TEST REPORT

**PRODUCT: Granite Stone Faced Aluminum Honeycomb Panel System
(Alternate Fiberglass Product)**

Report No.: H0981.02-106-31

Project Summary: Architectural Testing, Inc., an Intertek company ("Intertek-ATI"), was contracted by TerraCore Panels, LLC to evaluate two variations of their granite stone faced aluminum honeycomb panel system (edge sealed and unsealed test conditions) with an alternate fiberglass product layer. The product description, test procedures, and test results are reported herein.

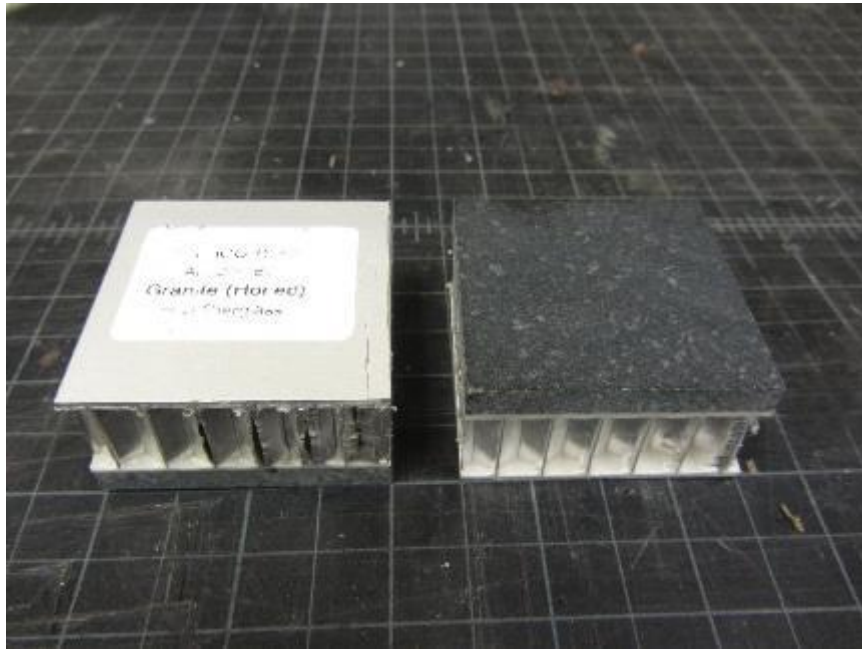
Photo No. 1

Typical Granite Faced Unsealed Edge Honeycomb Core Panel Specimen Pretest Condition

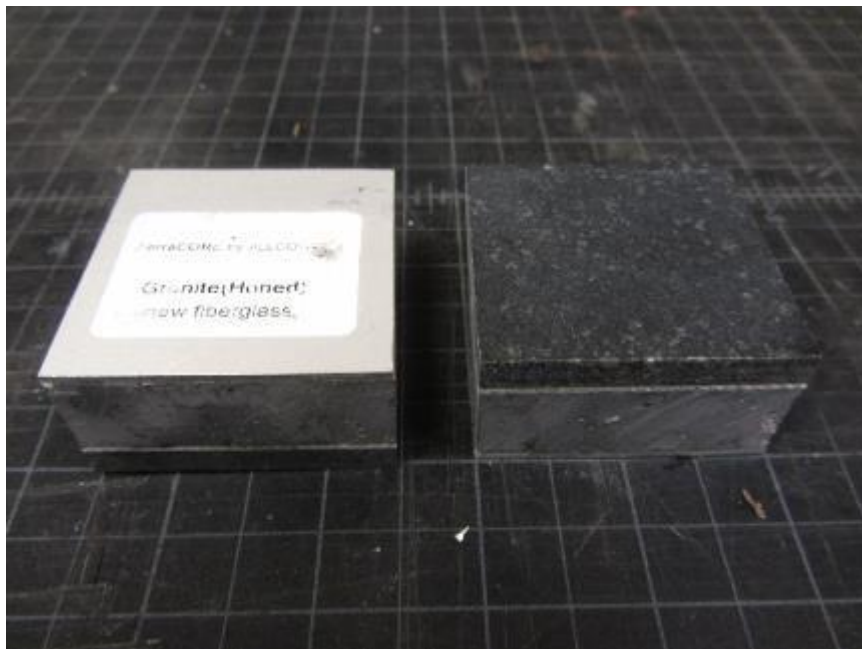
Photo No. 2

Typical Granite Faced Sealed Edge Honeycomb Core Panel Specimen Pretest Condition

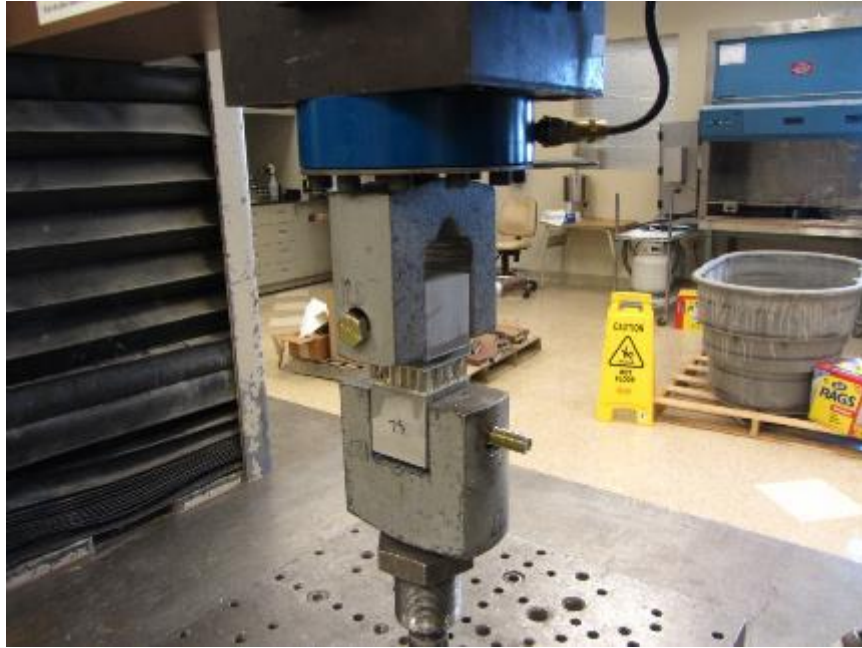
Photo No. 3
ASTM C297 Flatwise Tensile Bond Strength Test Apparatus – Unsealed Specimen

Aluminum pull tabs were affixed to both the front (stone) and rear (aluminum) panel facings of each specimen using a high performance epoxy adhesive (Loctite EA E-40HT) and allowed to cure for a minimum of 48 hours prior to testing. The length and width of each bond strength test assembly was measured with a 6" x 0.001" digital caliper (ICN: 65688) prior to installation in appropriate test fixtures and evaluation utilizing a SATEC 50 UD Universal Testing Machine (ICN: Y002011). Tensile load was applied to each assembly at a uniform crosshead speed of 0.02 in/min until failure of the specimen was observed. Peak tensile load and failure mode/location was recorded for each specimen. Flatwise bond strength was calculated in accordance with section 13.1. regarding tensile load at failure/calculated cross-sectional area. Mean percent post-freeze-thaw exposure cycling tensile bond strength reduction was determined by evaluation against results of the laboratory control series.

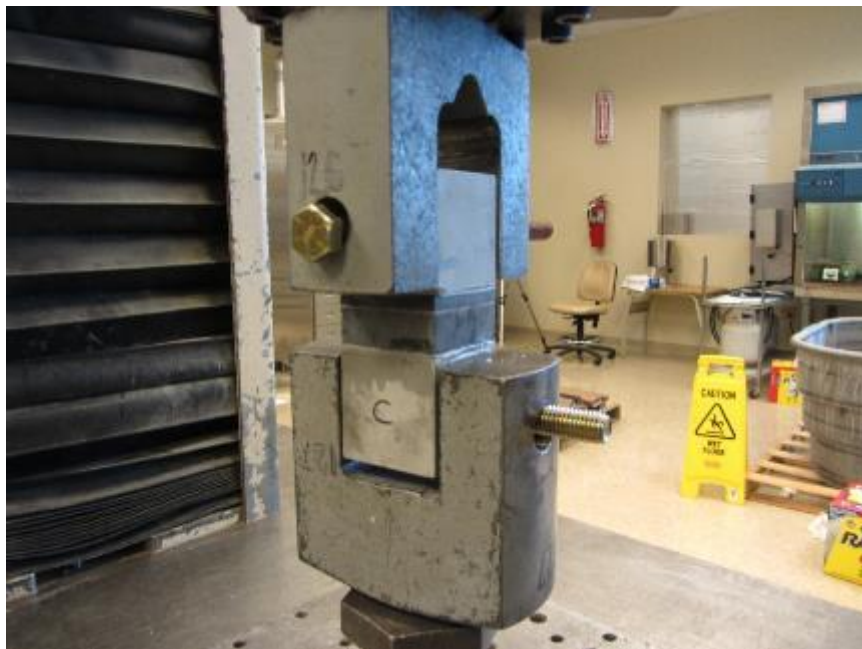
Photo No. 4
ASTM C297 Flatwise Tensile Bond Evaluation Loading Detail – Sealed Specimen

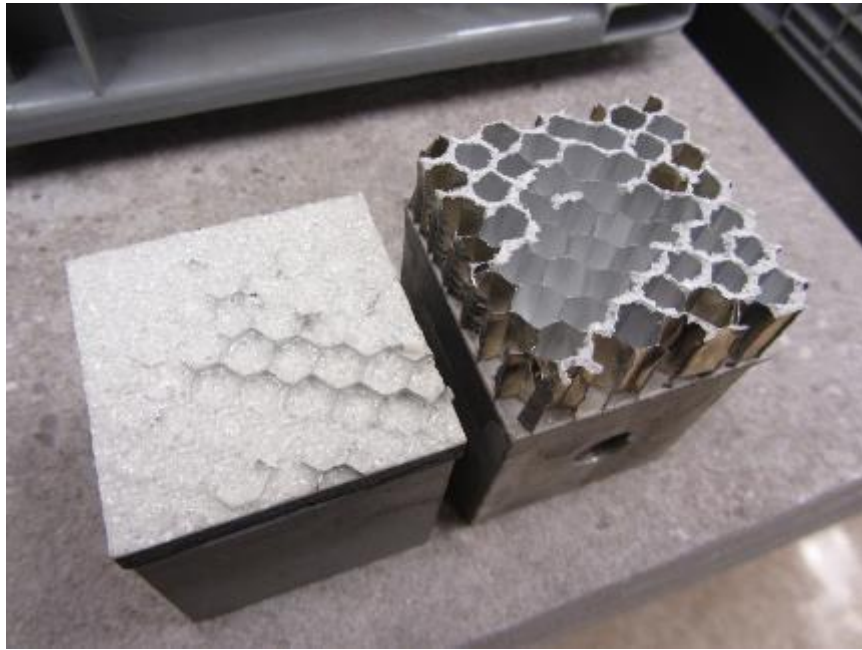
Photo No. 5
Fiberglass Scrim / Honeycomb Core Bond Failure Mode Detail

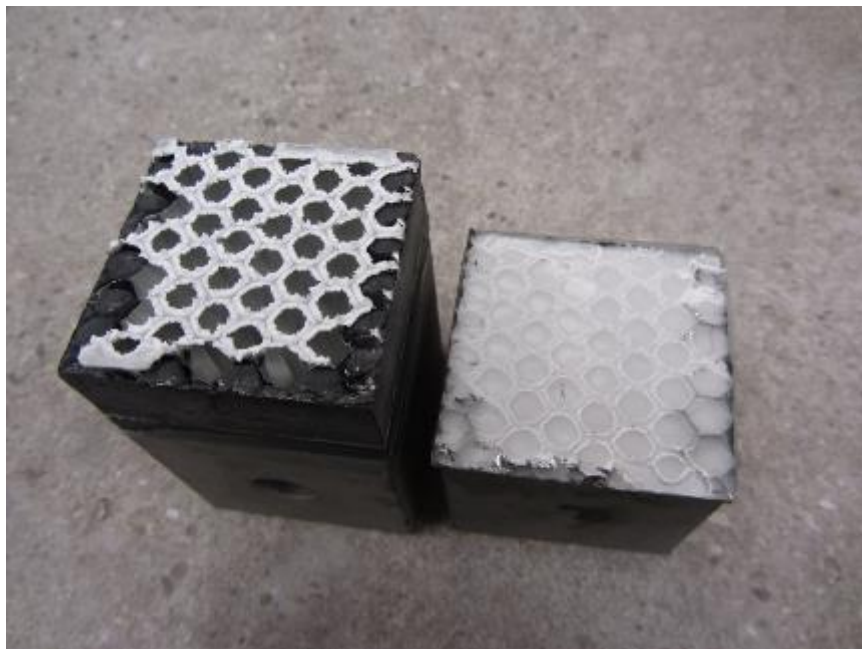
Photo No. 6
Aluminum Rear Face / Honeycomb Core Bond Failure Mode Detail

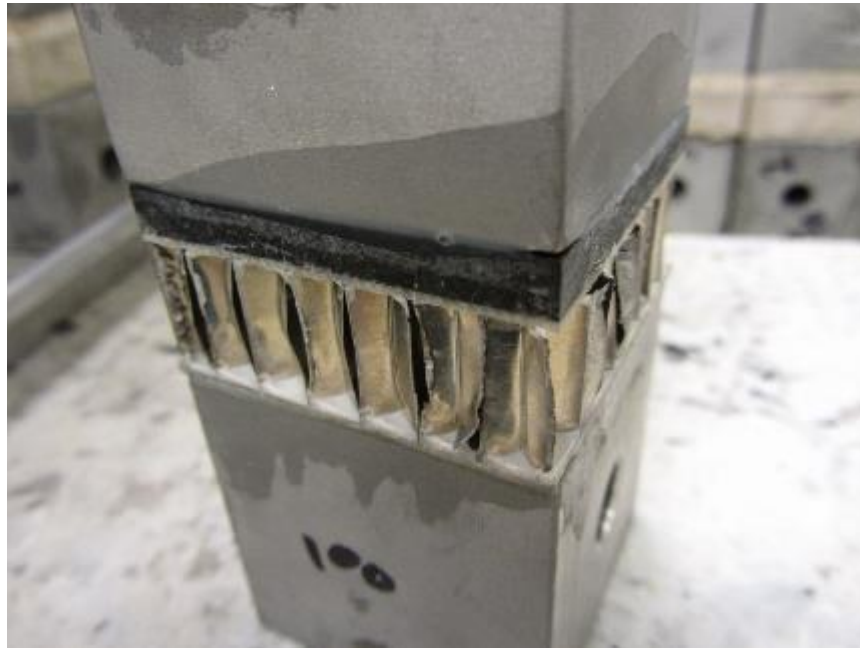
Photo No. 7
Representative High-Exposure Cycling (100 Cycles Completed) Unsealed Edge Specimen
Showing Deformation of Honeycomb Core from Interior Water Freezing/Expansion

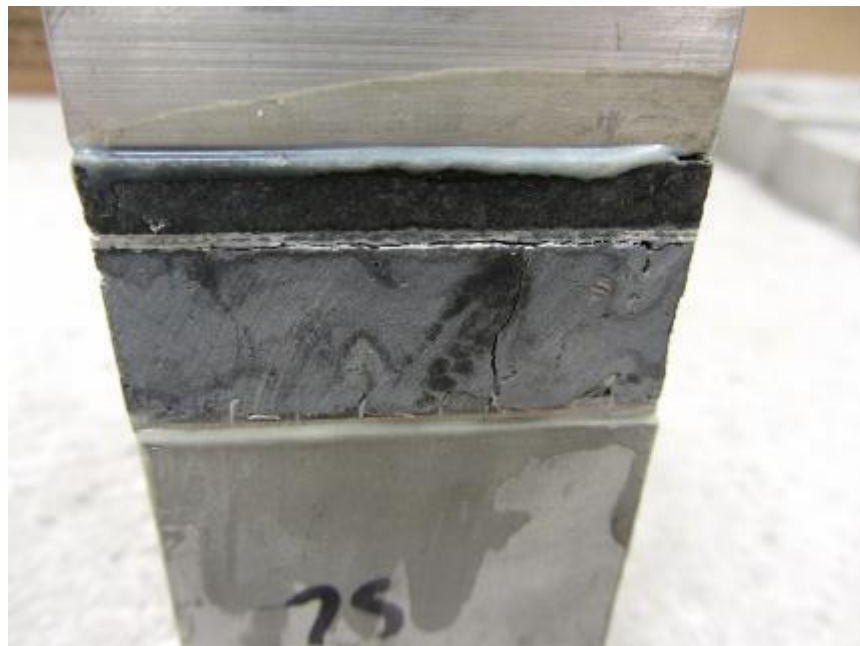
Photo No. 8
75-Cycle Sealed Edge Specimen Exhibiting Cracking from F/T Cycling

- Rupture of edge seal was observed in specimen nos. 75S-2 and 75S-5 at 75 cycle completion

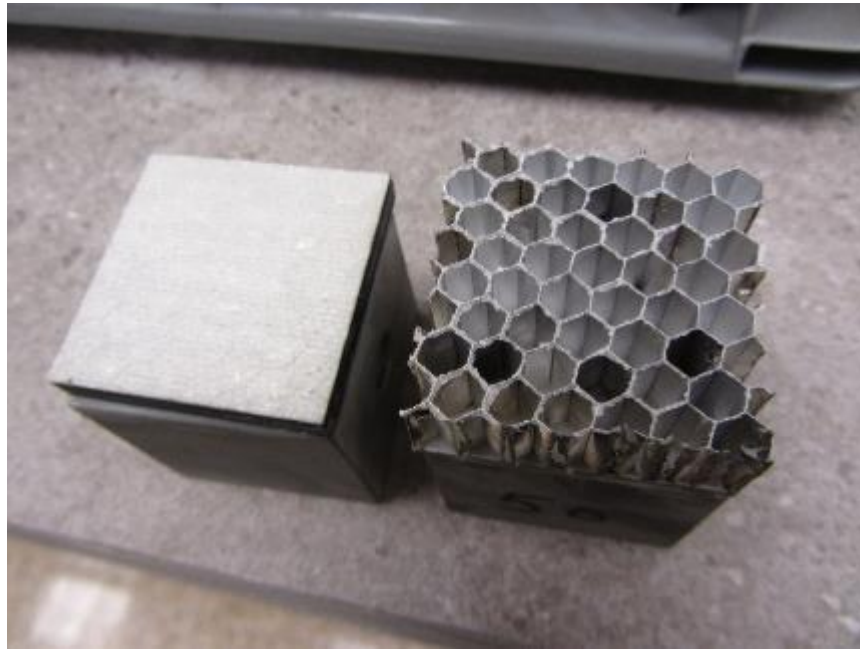
Photo No. 9
Representative Light Adhesive Application Bond Layer Detail – Unsealed Specimen

- *Unsealed specimen nos. CU-2 and CU-5 showed light adhesive application at failure bond layer*

- *Unsealed specimen nos. 50U-2 and 50U-4 showed light adhesive application at failure bond layer*

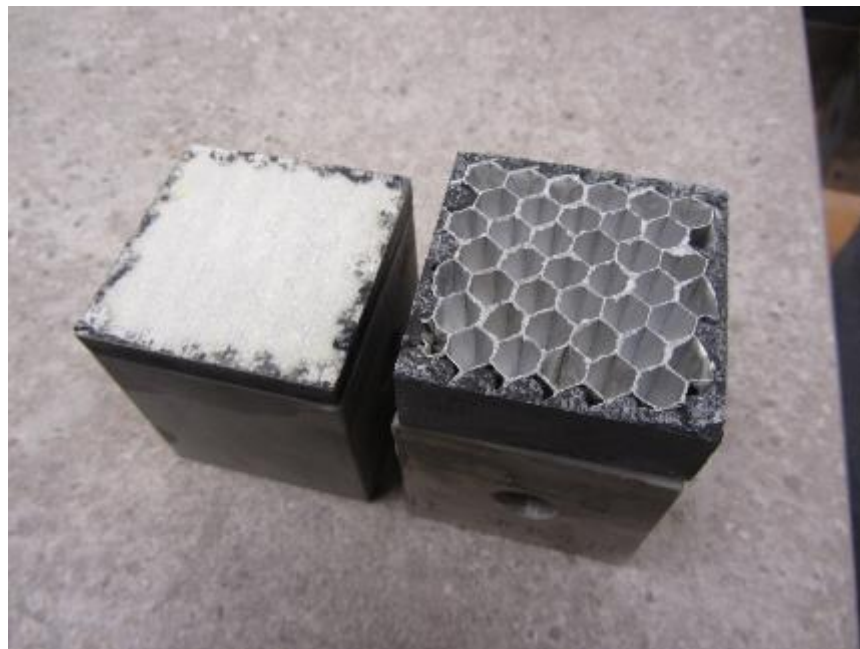
Photo No. 10
Representative Light Adhesive Application Bond Layer Detail – Sealed Specimen

- Sealed specimen no. 75S-2 showed light adhesive application at failure bond layer

- Unsealed specimen no. 100U-1 and Sealed specimen nos. 100S-4 and 100S-5 showed light adhesive application at failure bond layer
